# Anatomy of a shaft crack

When Hugh Stott, Steam Turbine Engineer for Public Service Electric and Gas (PSEG) received the report of high vibration on Unit No. 7 steam turbine generator at the Burlington, New Jersey power station, he knew the problem was serious.

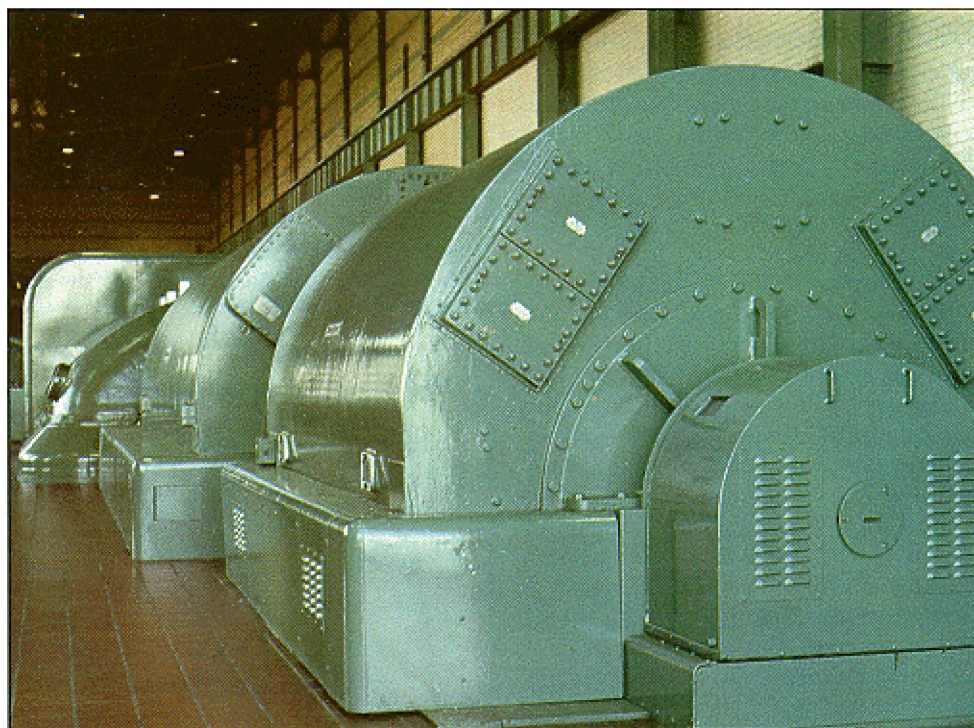
**The analytical methods used by PSEG enabled their engineers to properly diagnose the shaft crack on the 30-year-old steam turbine generator.**
